# ***Japan and Fukushima Dai-ichi***

**Presentation to  
NSTC Subcommittee on Disaster Reduction**

**Steven West  
Deputy Director, Office of Nuclear Regulatory Research  
U.S. Nuclear Regulatory Commission**

**May 1, 2014**

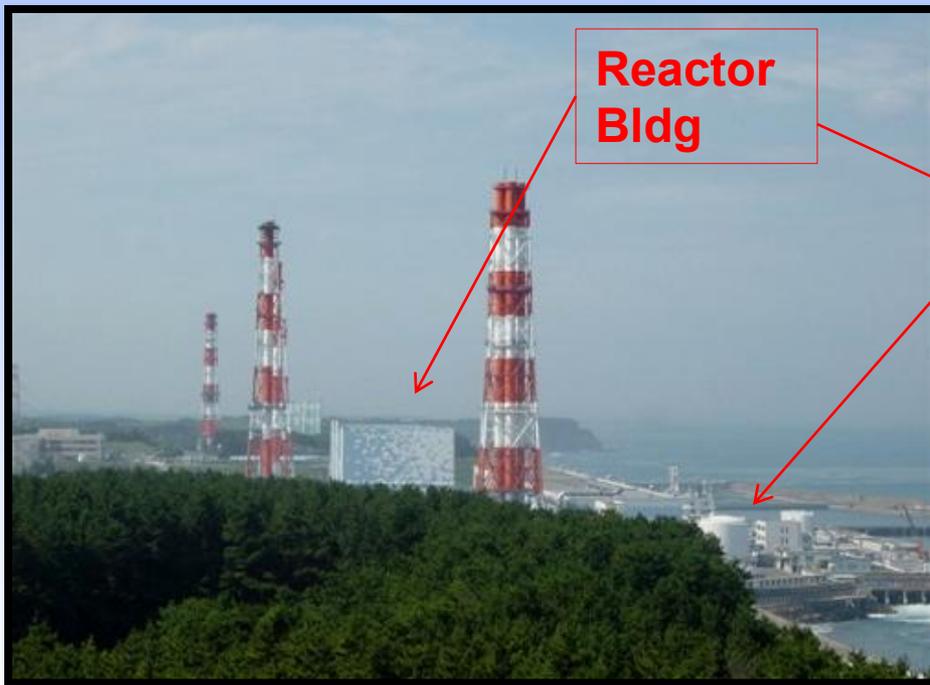
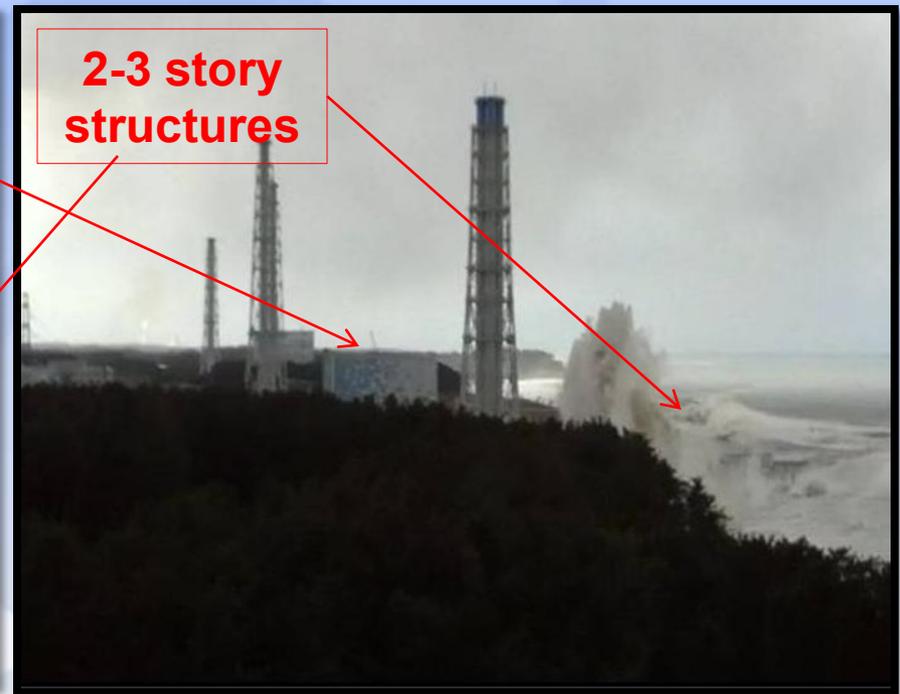
# Tsunami

- Site designed to withstand 19 foot tsunami
- Hydrodynamic forces were not considered
- Actual height estimated 46 - 49 feet

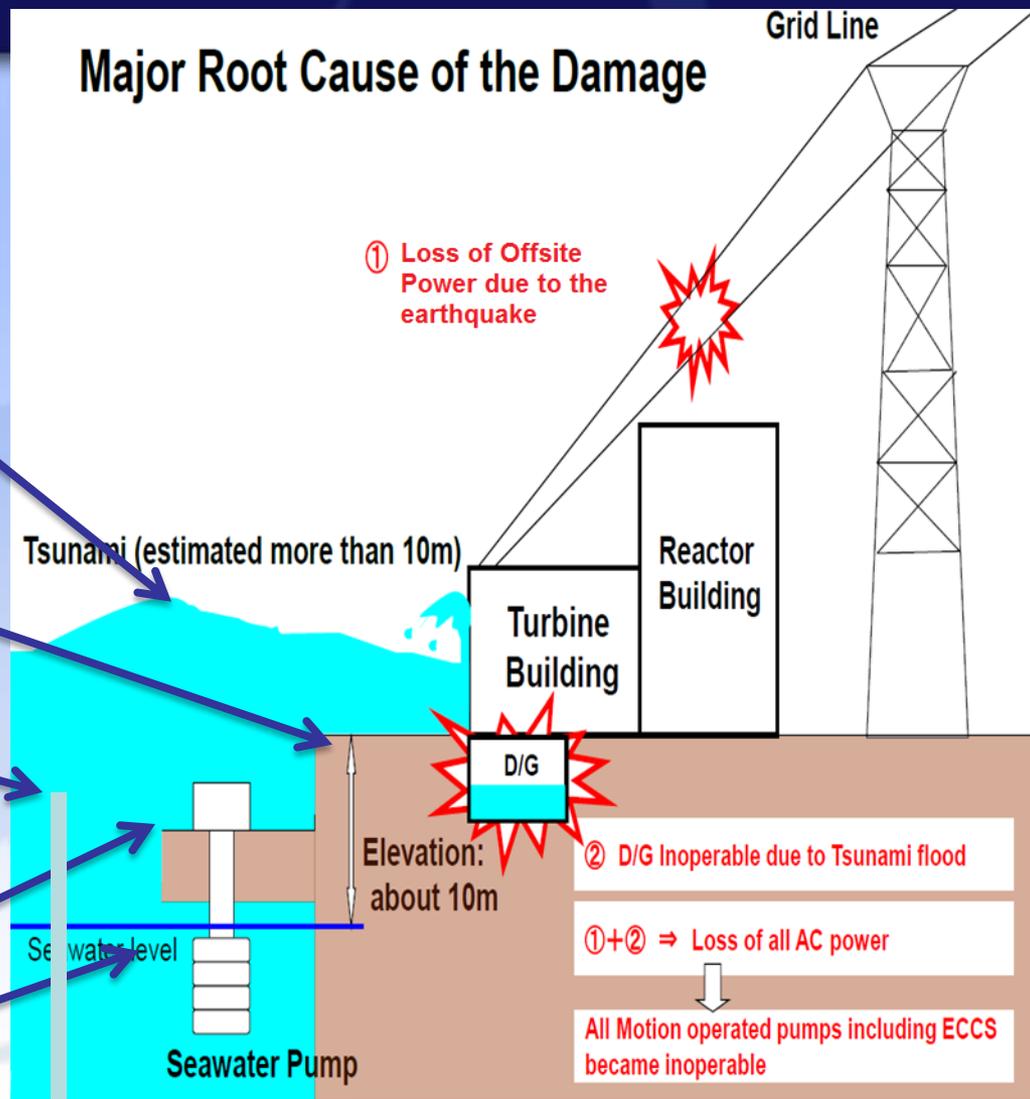
# Flood Damage

- 46 feet. Tsunami Peak Elevation
- 42.5 feet Ground elevation of Units 5-6 TB/RB
- 33 feet Ground elevation of Units 1-4 TB/RB
- 17 feet Assumed highest tsunami and elevation of break wall
- 13 feet Ground elevation of intake structure
- 0 Feet Sea level

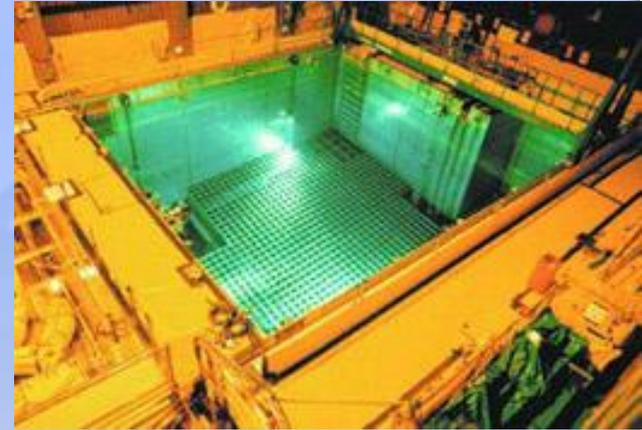
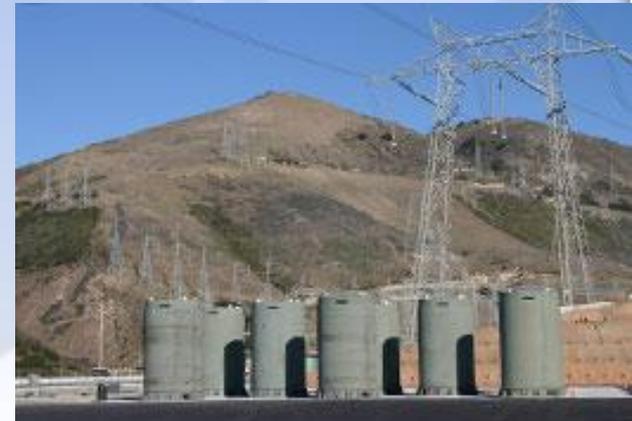
# Unit 4 and Spent Fuel Safety

- Dry cask storage was flooded but fuel remained cool
- Spent fuel pools maintained structural integrity
- Unit 6 diesel generator provided heat removal to the Units 5 and 6 pools and the fuel in the cores
- Unit 4 spent fuel pool
  - Elevated temperatures was a concern
  - **Hydrogen explosion** due to backflow of hydrogen from Unit 3 gas treatment system
  - Concern diverted attention from the reactors

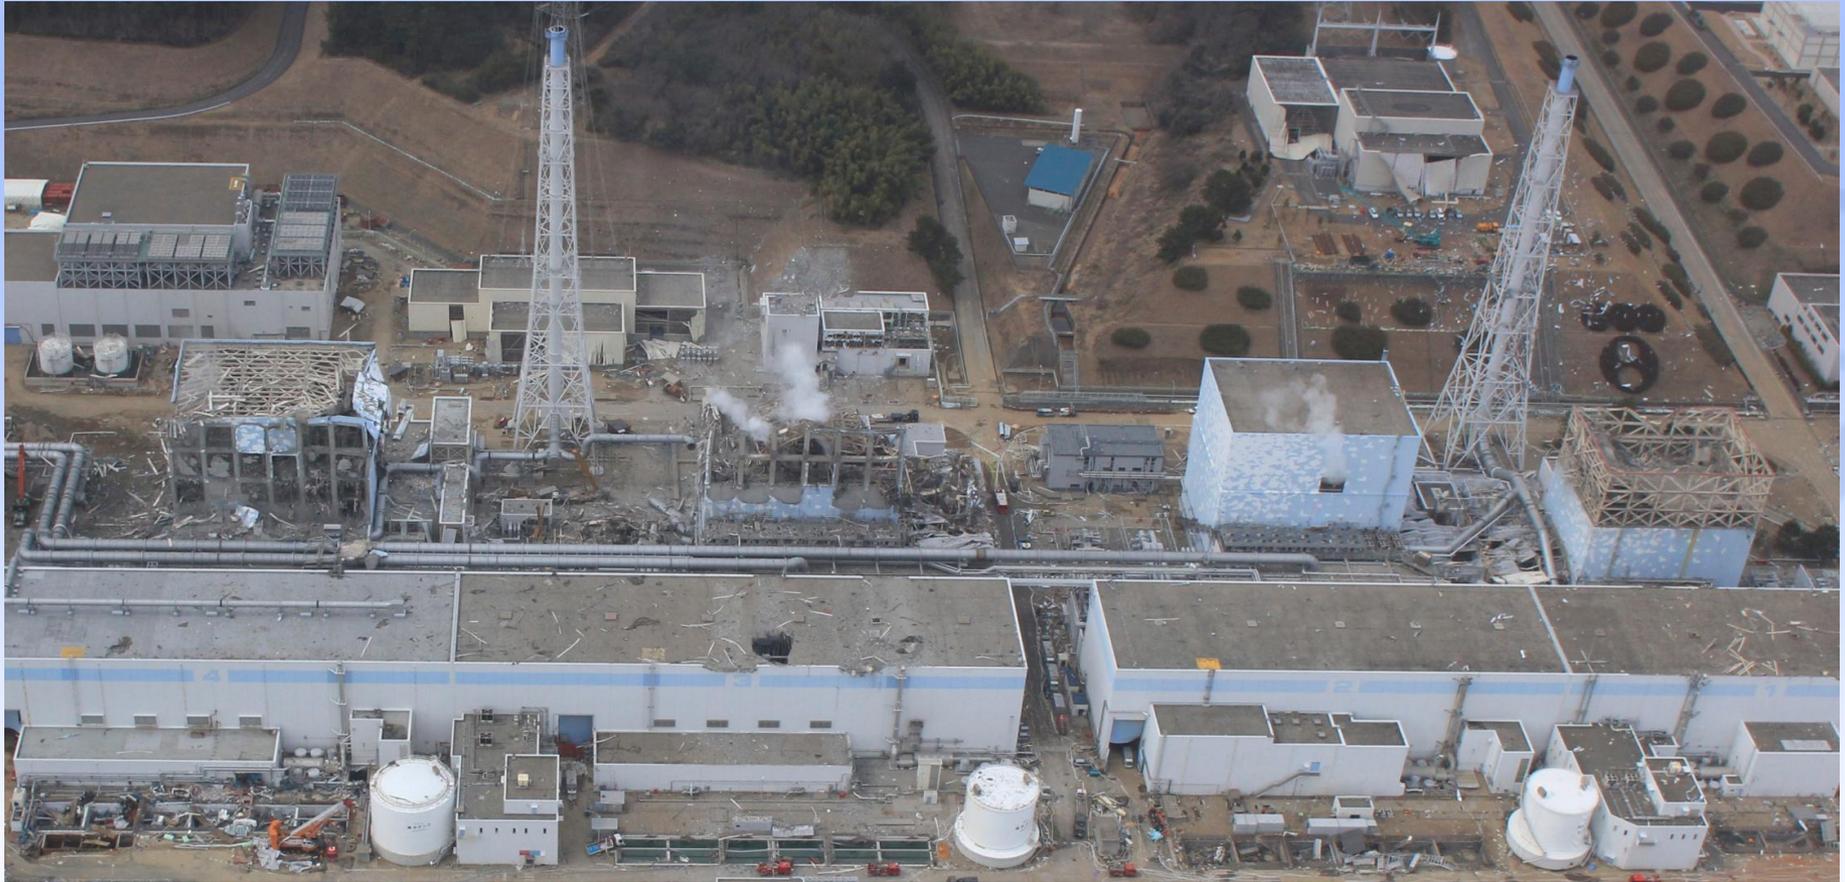
# *After Hydrogen Explosions*

**UNIT 4**

**UNIT 3**

**UNIT 2**

**UNIT 1**

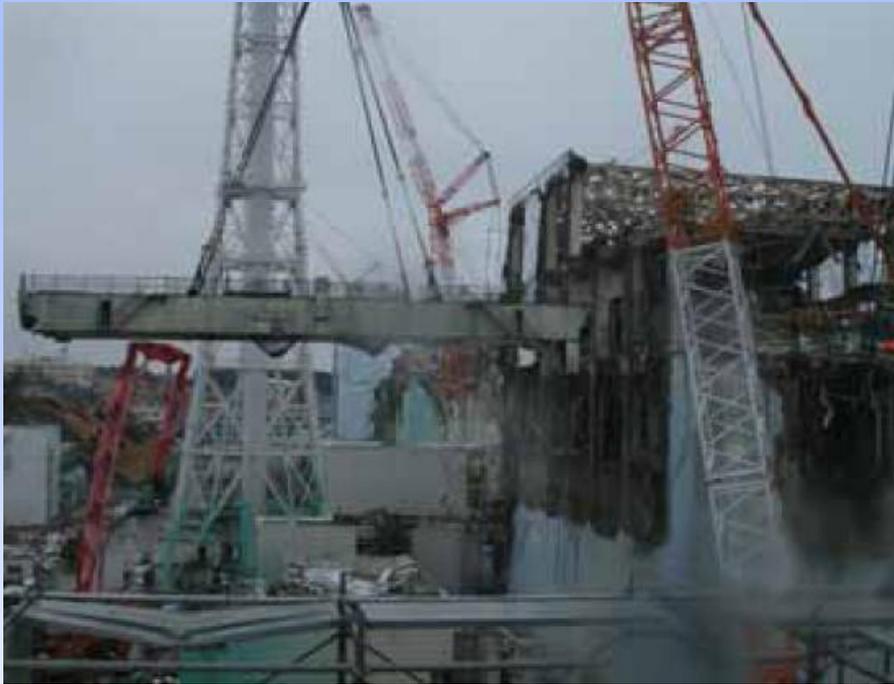
**Removing Rubble from Unit 4  
March 3, 2012**
