Performance of Transportation Infrastructure During the Wunchuan Earthquake, China on May 12, 2008

W. Phillip Yen, Ph.D., P.E.
Seismic Research Program Manager
Office of Infrastructure, R&D FHWA

SDR Monthly Meeting
October 9, 2008

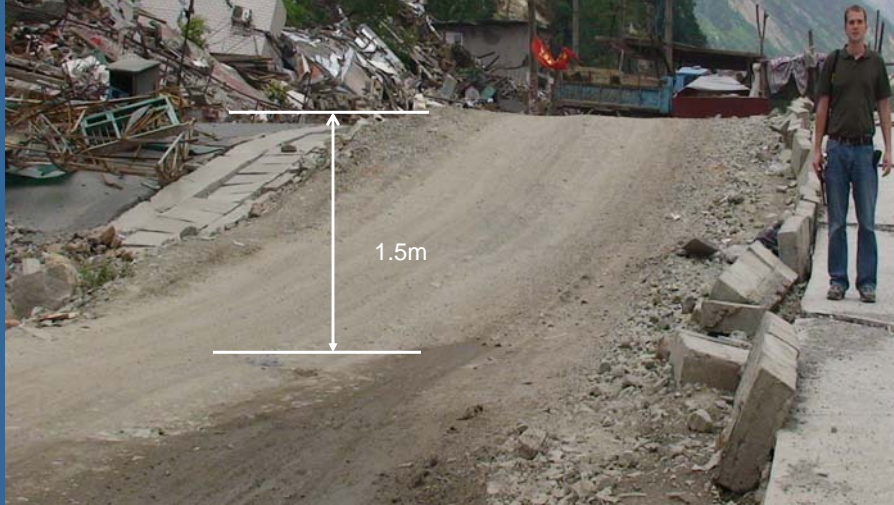
Surface Rupture along the Old Highway near the Collapsed Building

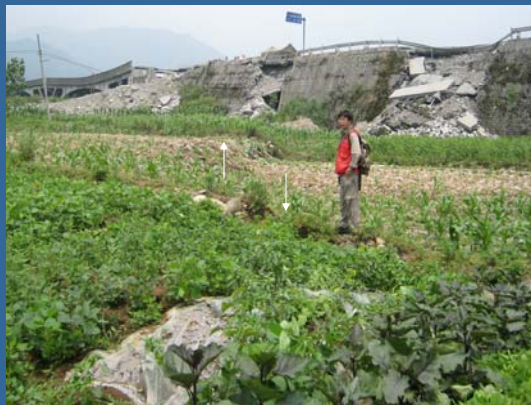
Surface Feature of Fault Rupture near the Xiaoyudong Bridge

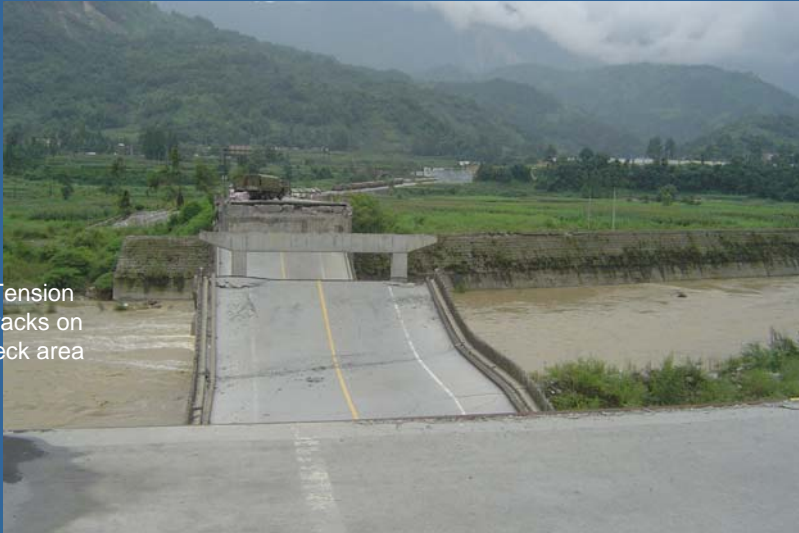
Tension
cracks on
deck area

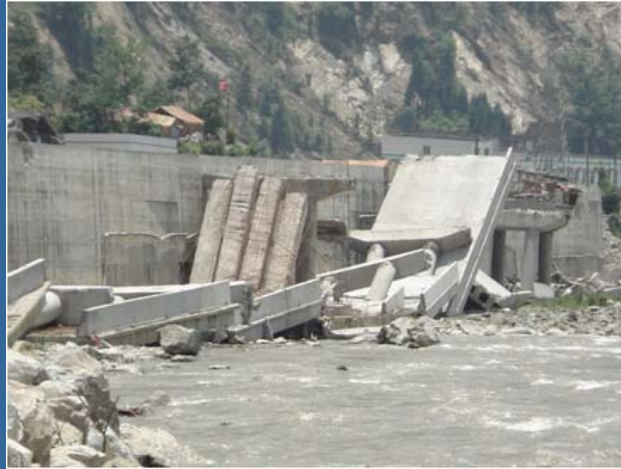
Shunhe bridge totally collapsed in Yingxiu
(bridge longitudinal direction was parallel to
the fault line)

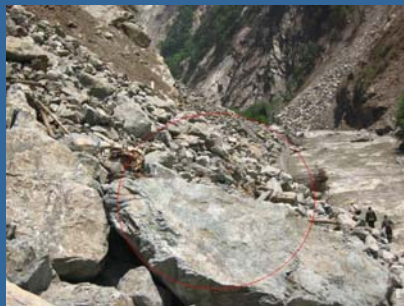
Landslide buried the
bridge on Ying-Ri Road

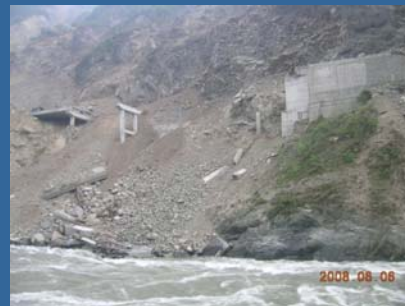
Landslide crushed the
bridge on Du-Wen
Road

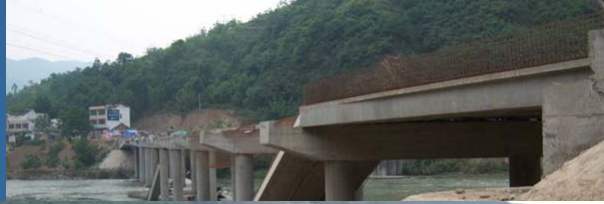
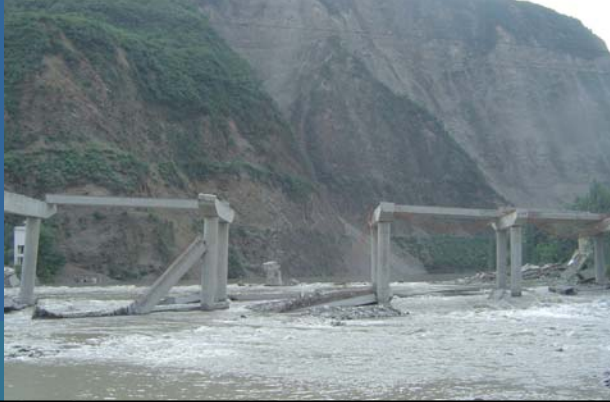
Nanba Bridge

- Fault rupture caused the bridge span to collapse.
- Decks were pushed to abutment area.
- 10 spans with 25m/span
- Bridge was under construction
- Simply supported girders

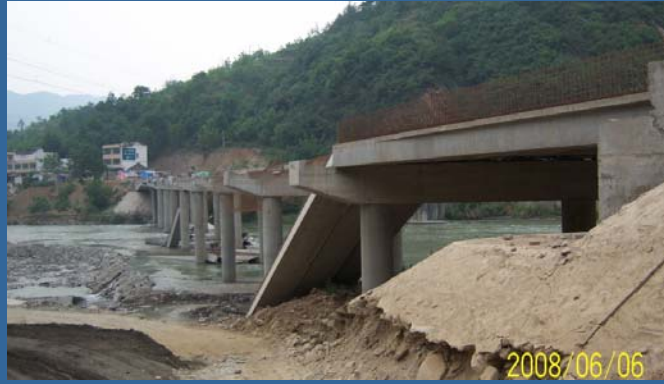
**Pull-off-and-drop
collapse of
bridge deck**

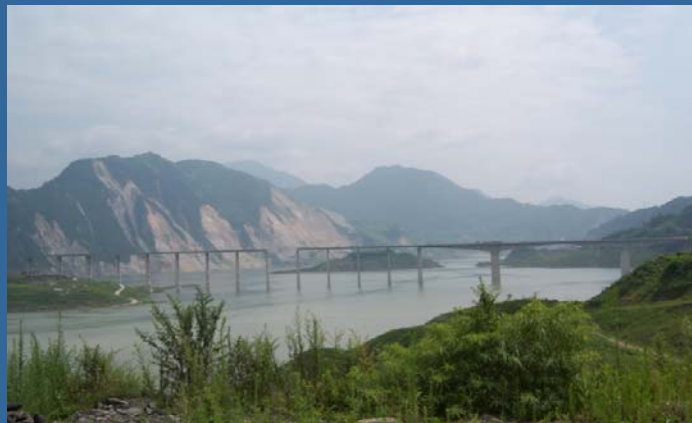
- **Miaoziping bridge**
- **One span of was unseated during the earthquake.**
- **Bridge was under construction**

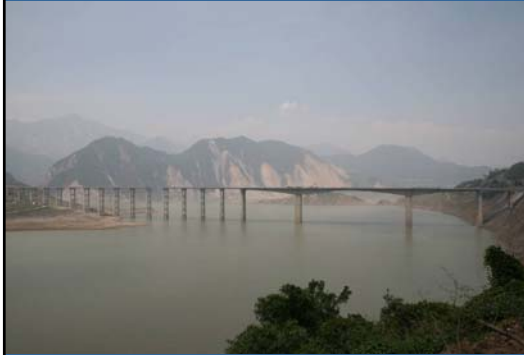
Miaoziping bridge:

- Simply supported spans, one span collapsed
- Rigid frame spans, little damage

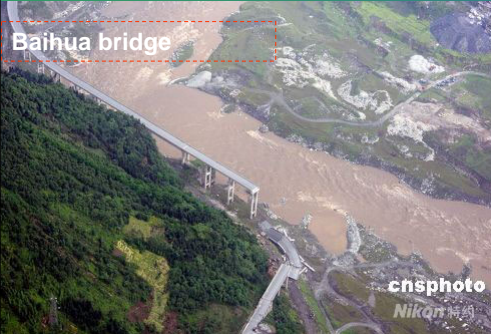
1. Constructed in 2004
2. 18 spans and 450m long
3. Piers, bearings and tie beams failures
4. 5 curved spans totally collapsed
5. Demolished after the earthquake

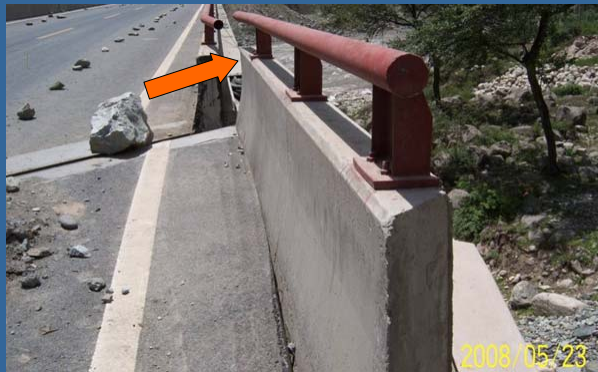
Gaodian
bridge in
Wenchuan

Offset in
transverse
direction

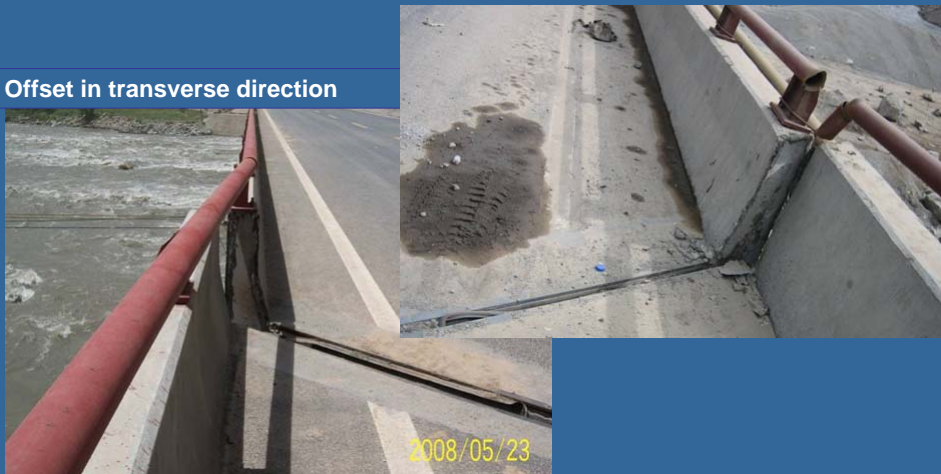
Offset in transverse direction

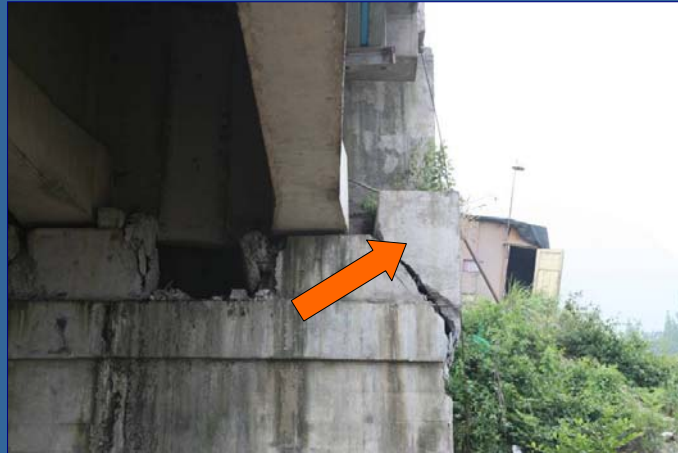
Shear key failure

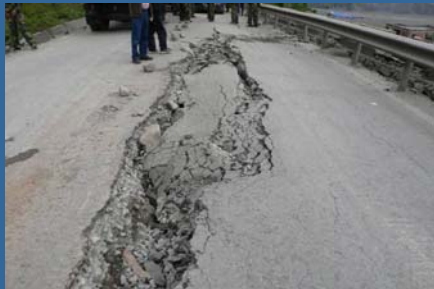
Rupture

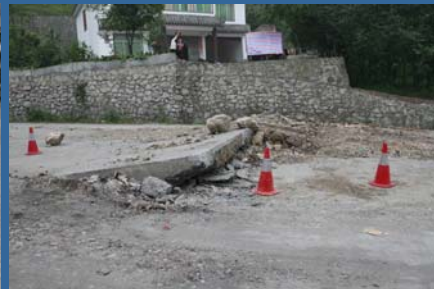
Upheaval

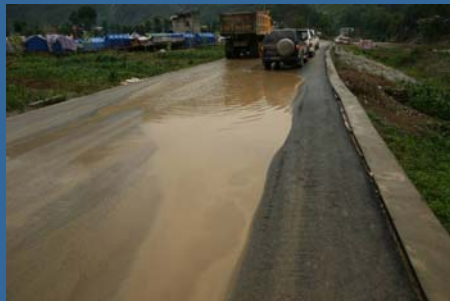
Settlement

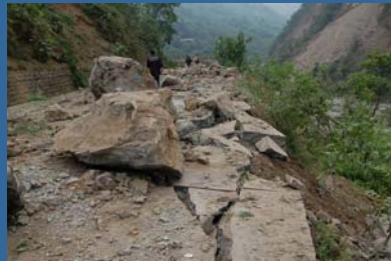
Crushing

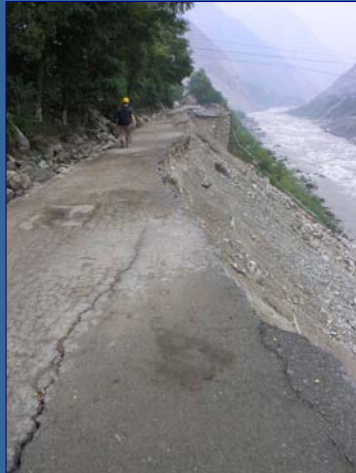
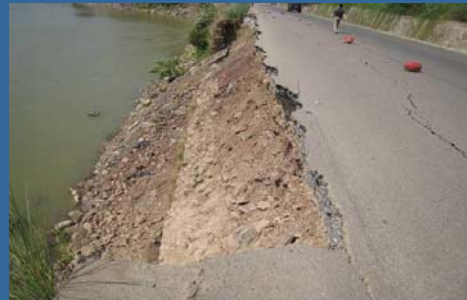
cave-in collapse caused by the failure of the retaining wall

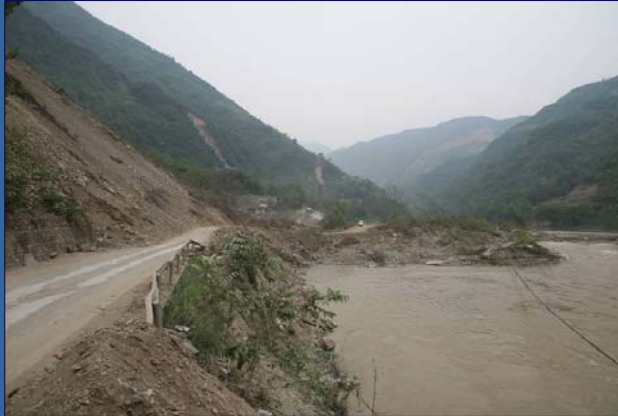
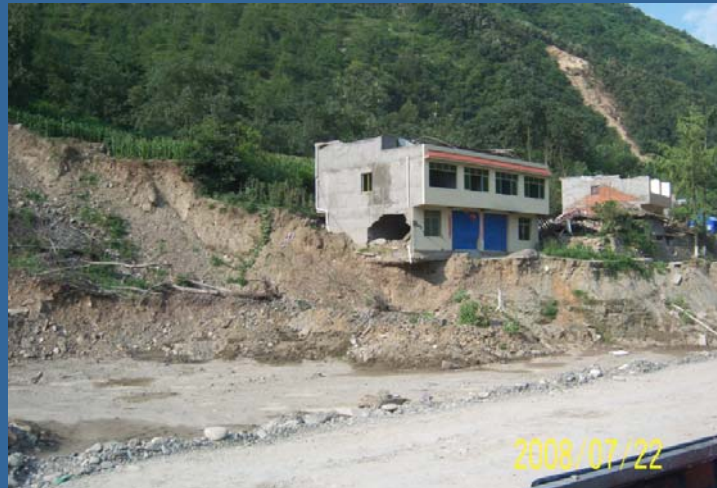
Landslide
up to 200
meter

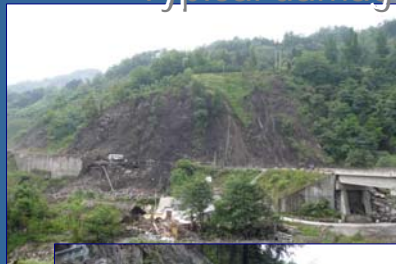
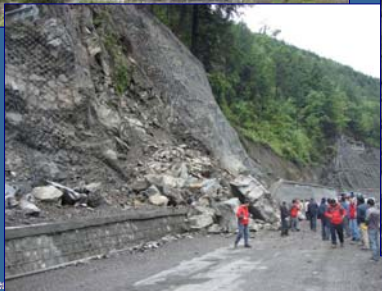
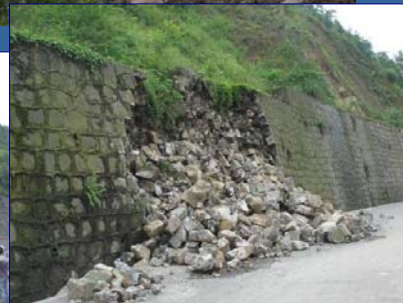
Typical damages of Retaining Walls

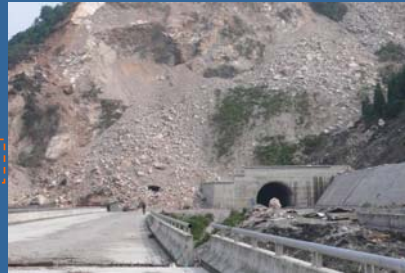
Tunnel & side slope damages

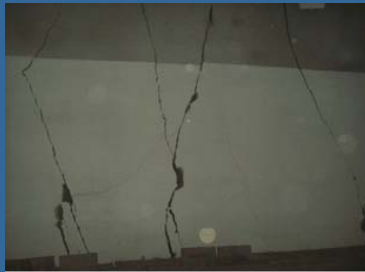
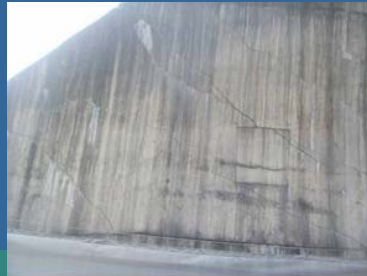
tunnel-liner cracks

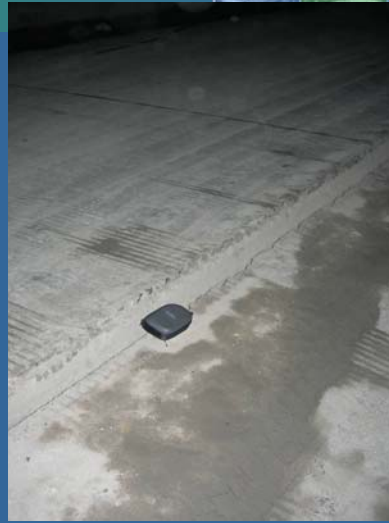
Construction joint offset

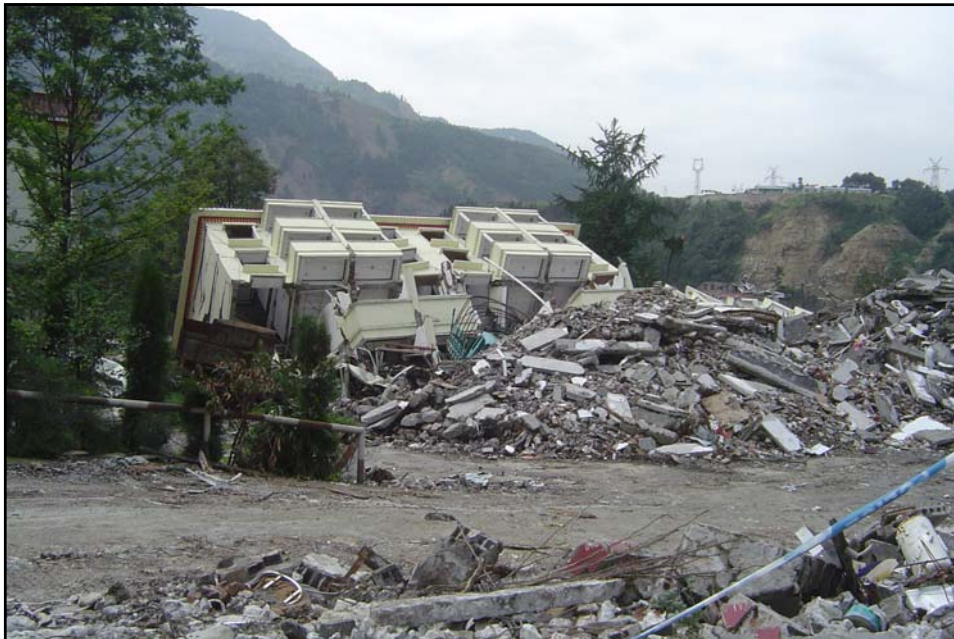
inverted upheaval
