# The SR530 landslide: March 22, 2014

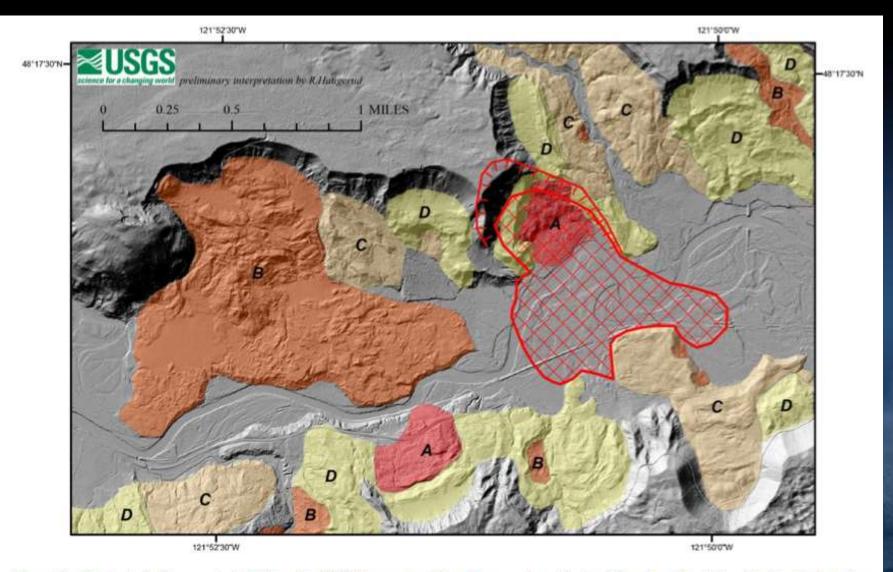
Figure 2. Shaded-relief image calculated from the 2013 lidar survey. Colored areas show older landslide deposits, distinguished by their relative age: A, youngest to D, oldest. The red cross-hatched area marks the approximate extent of deposits from the March 22, 2014, landslide.

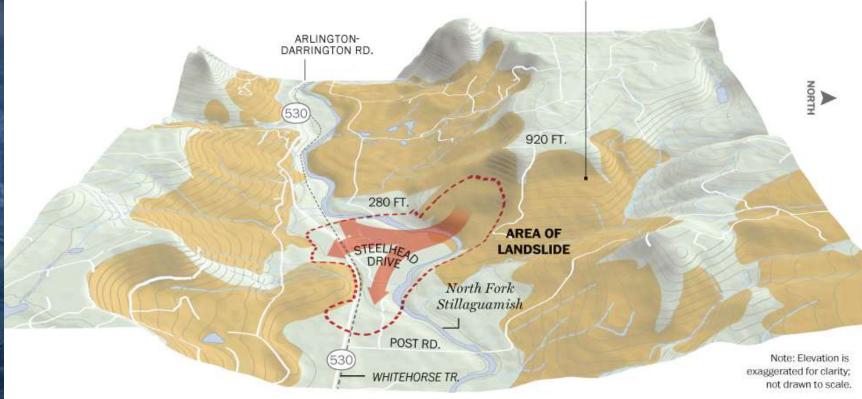
The ridge where the slide occurred rises more than 600 feet above the river, in the foothills of the Cascades. The river constantly erodes soil along its banks.

Much of the area rests on deposits from ancient landslides. Layers of sand, silt and clay were stacked and compressed in the Ice Age. Only friction holds them together, and they slide easily.

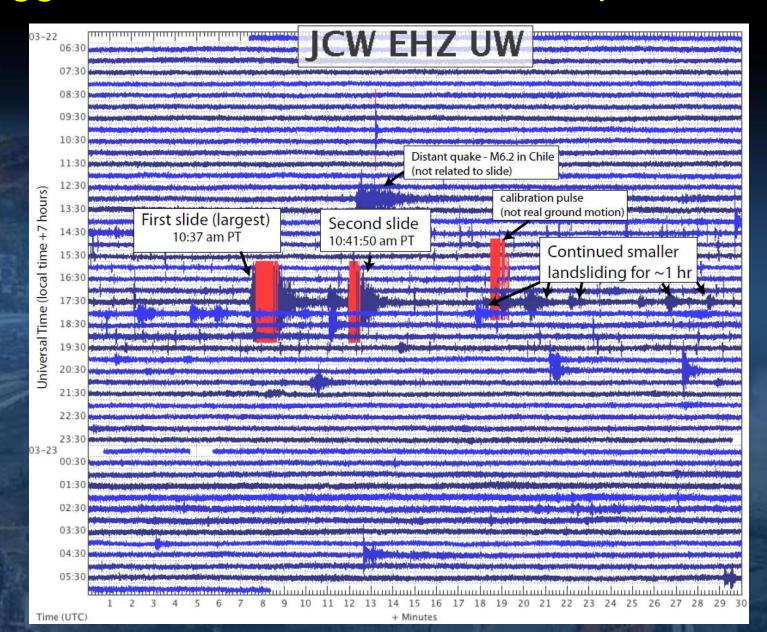
## What triggered the slide? Not an earthquake

Nearest station in Pacific Northwest Seismic Network

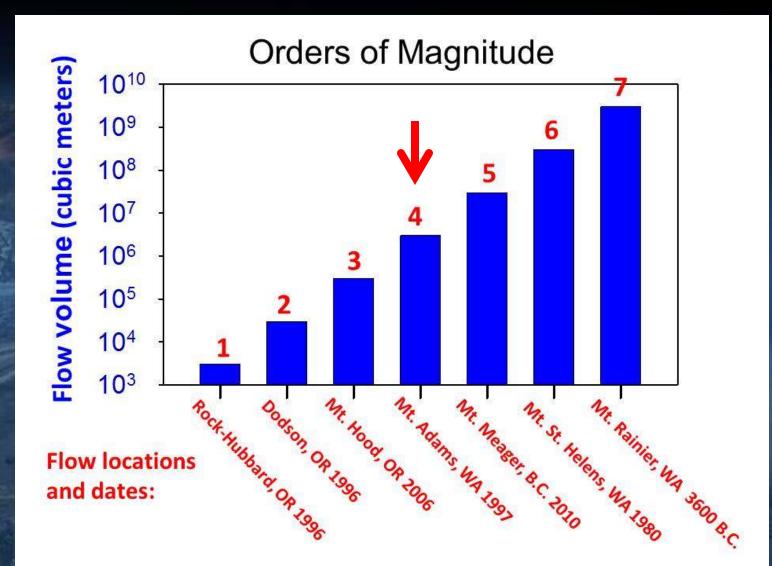
## Size of the slide

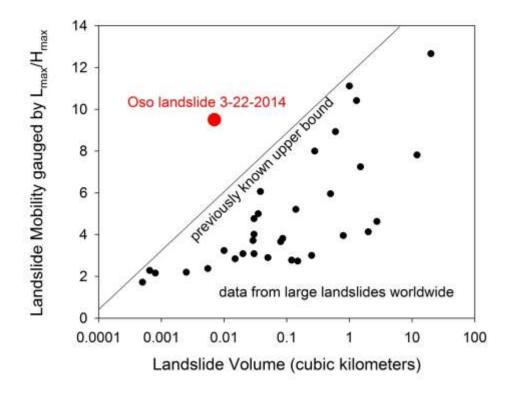
## An exceptionally mobile slide – fast and far

The exceptional mobility of the Oso landslide compared to worldwide data for non-volcanic landslides tabulated by F. Legros, Eng. Geol. 2002 (R.M. Iverson, USGS, 3-30-2014)

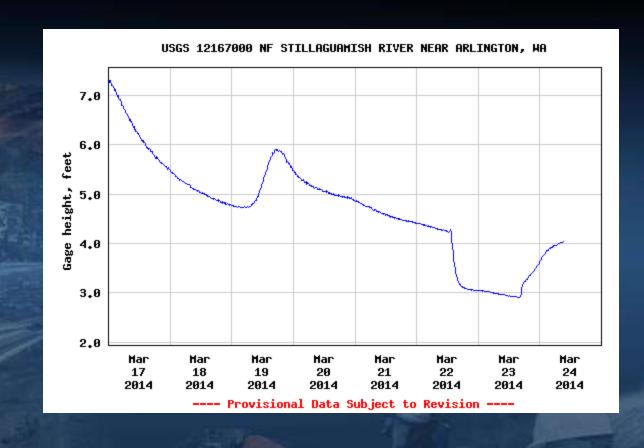
## Slide blockage reflected in downstream flow
