October Rainfall and Flooding in South Carolina: Impacts and Recovery

Susan L. Cutter
Hazards & Vulnerability Research Institute
University of South Carolina, Columbia, SC USA
scutter@sc.edu

Subcommittee on Disaster Reduction
Washington DC
November 5, 2015

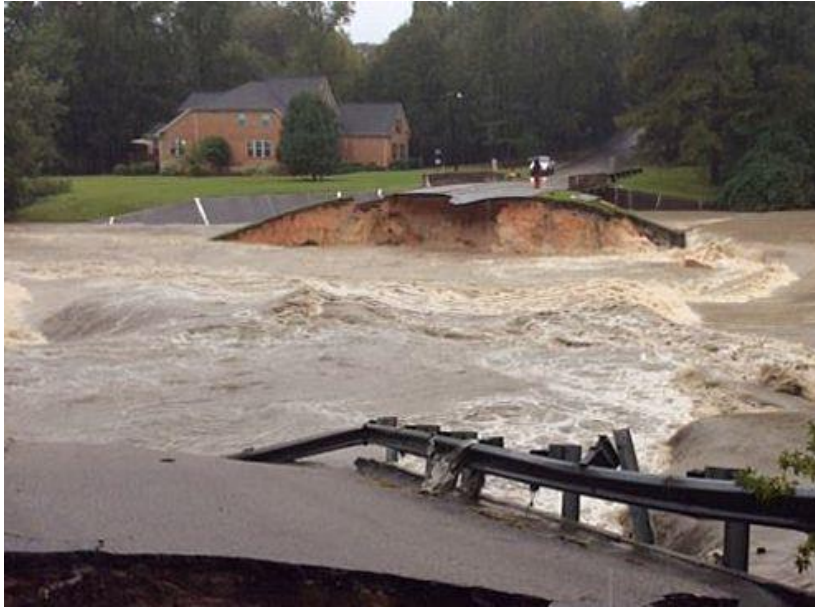
The Carys Lake Dam in Richland County, S.C., breached amid the historic flooding. (Facebook Photo/[Gills Creek Watershed Association](#))

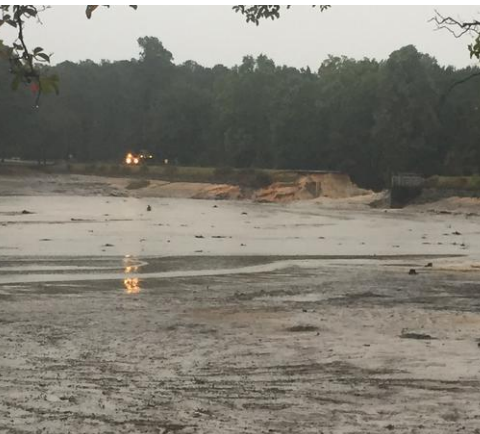
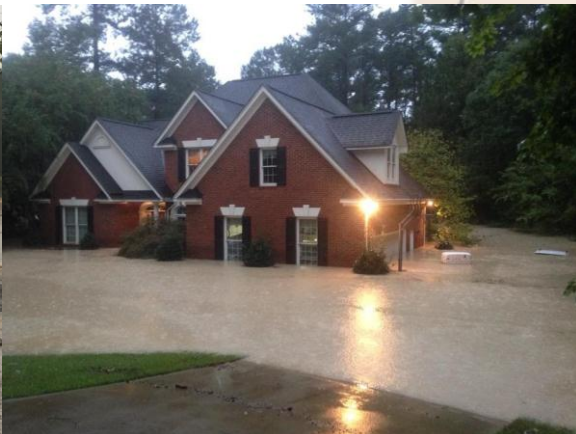
Semmes Lake dam collapse (L), Kings Grant neighborhood (R)

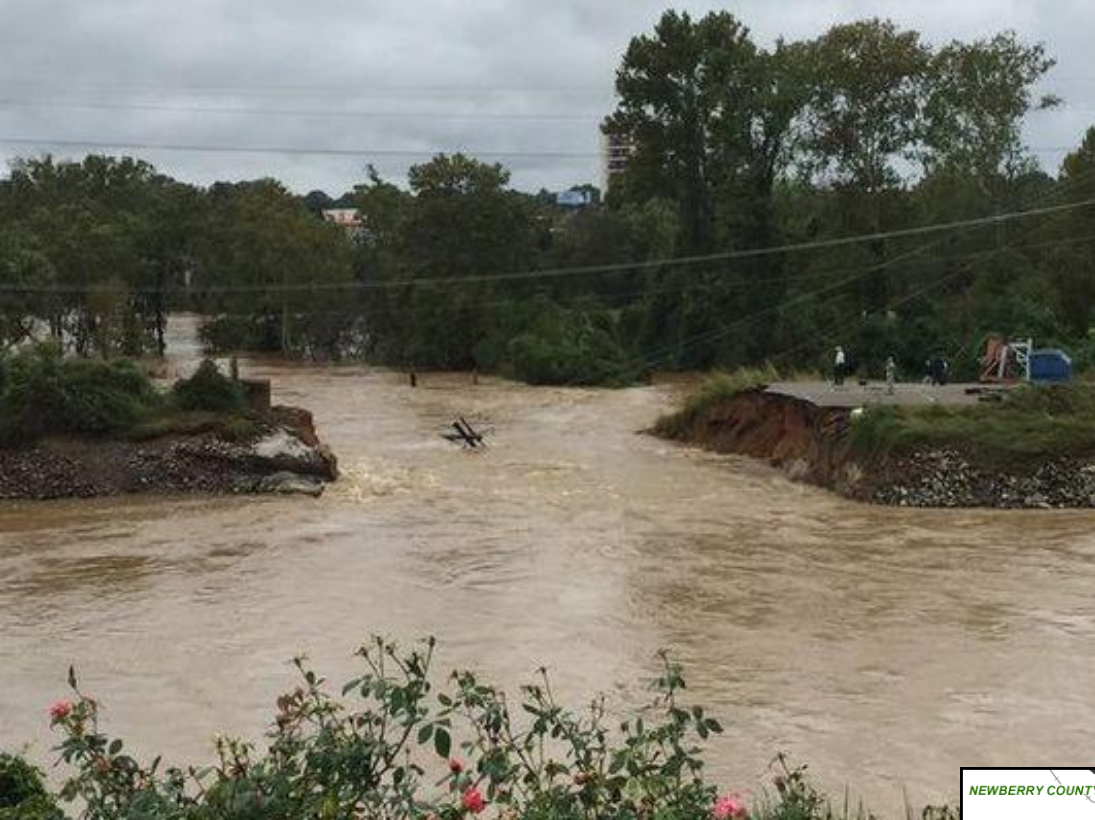
Road and Bridge Closures as of 0800 November 1, 2015

85 CLOSURES
57 Road Closures
28 Bridge Closures

Anticipated Openings
● After November 26th
● By November 26th
● By October 31st
