Central Italy Earthquakes of 2016

Dr. Michael L. Blanpied
USGS Earthquake Hazards Program
mblanpied@usgs.gov

For SDR, November 3, 2016

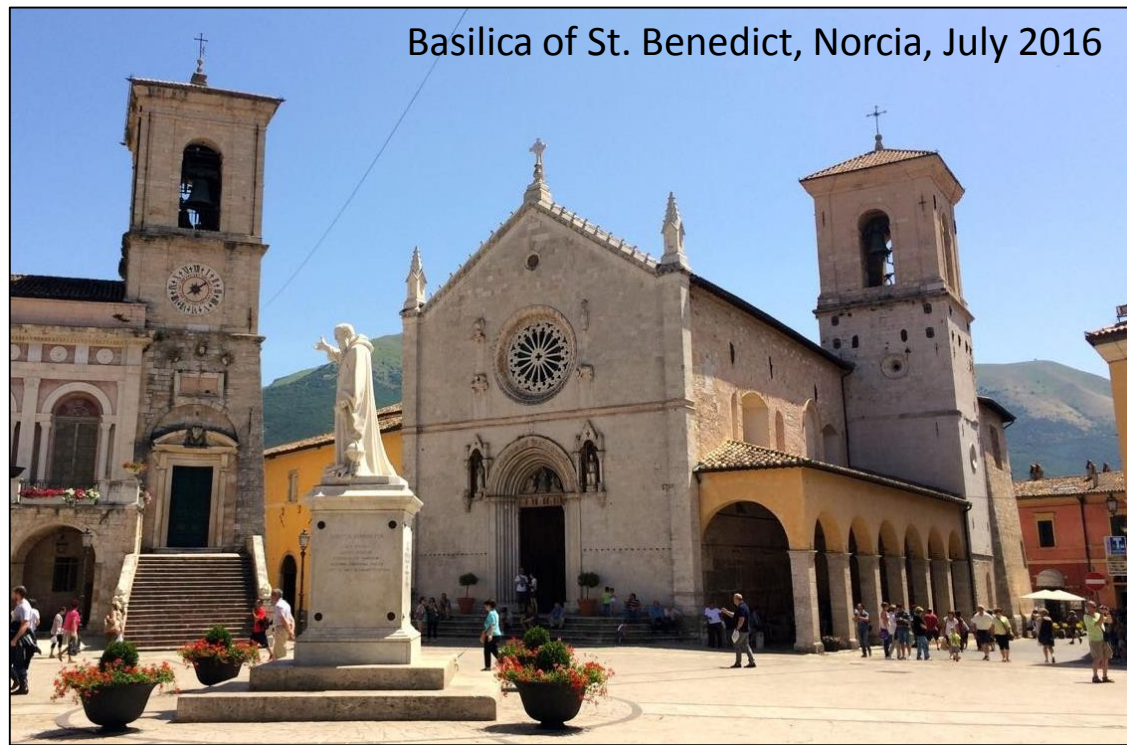
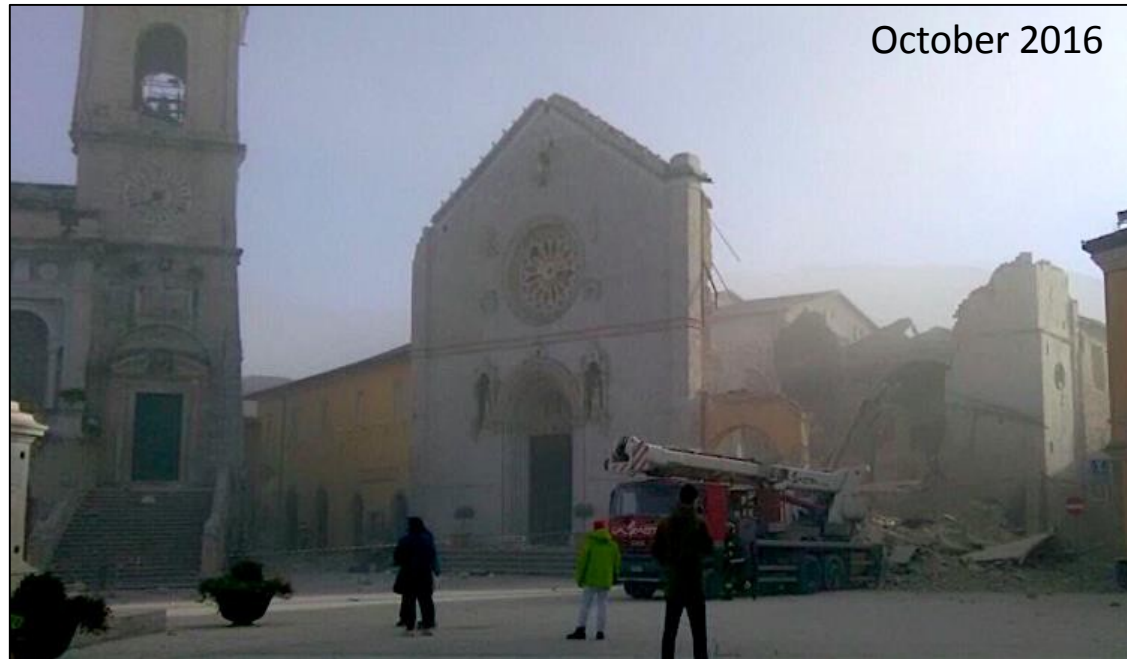
- Earthquakes have caused severe damage to unreinforced masonry structures, including many dating from ~1200 to ~1970.
- New and retrofitted structures have generally fared well.
- Following the deadly M6.2 earthquake of August 24, residents have avoided damaged structures and “red zones”, and have temporarily abandoned weak structures following larger earthquakes.

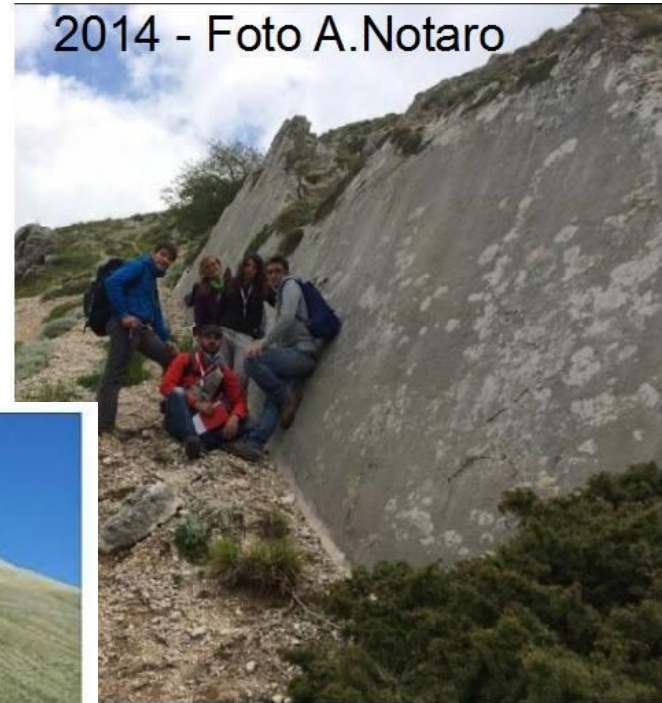
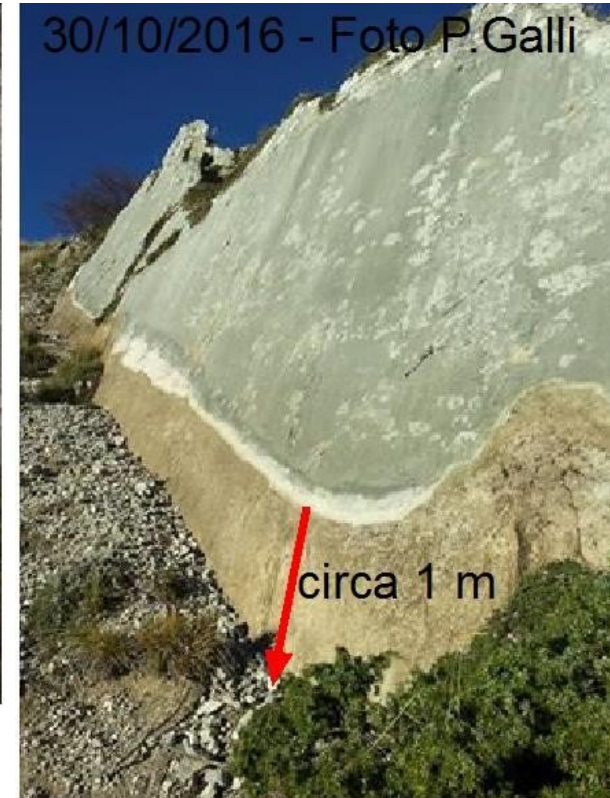
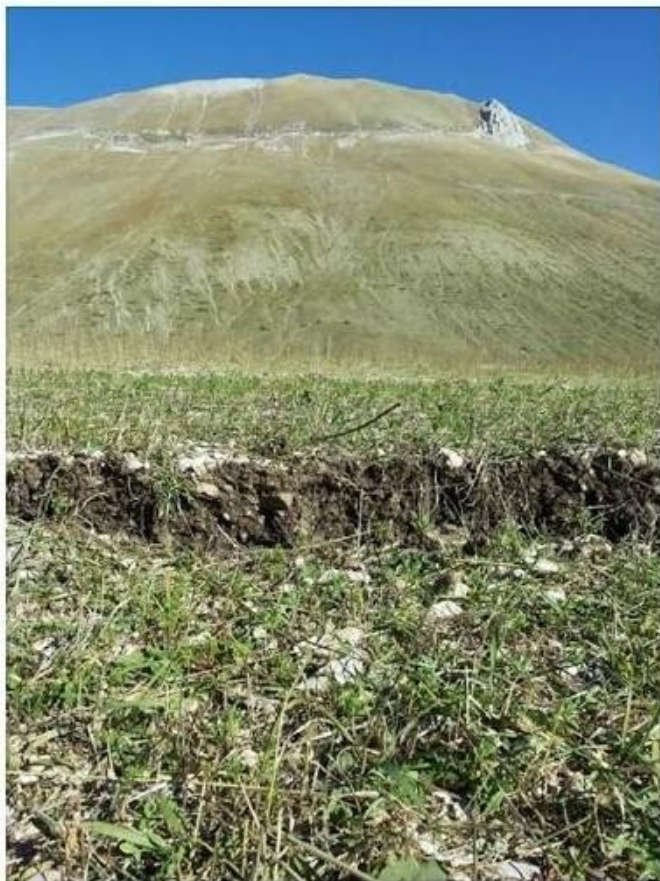
- Fault offset from M6.6 October 30 earthquake.
