Architectural Resilience for Disasters presented to the Subcommittee on Disaster Reduction Committee on Environment and Natural Resources, Natural Science and Technology Council

Janice Olshesky, AIA, LEED AP National AIA Disaster Assistance Committee Olshesky Design Group, LLC Alexandria, VA

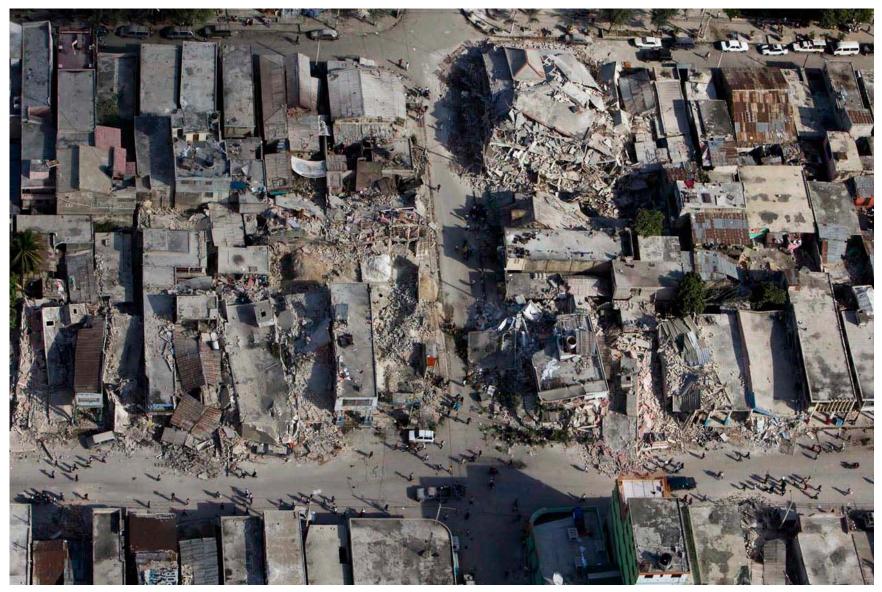
#### Downtown Port-au-Prince Ravaged by Quake, Haiti

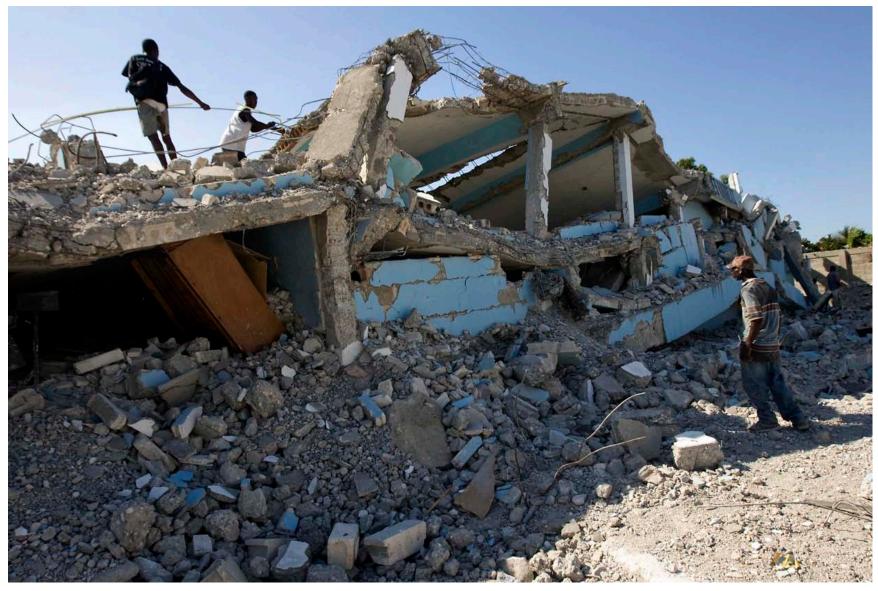
#### Salesian Mission School collapsed by Quake in Slum of Cite Soleil, Haiti

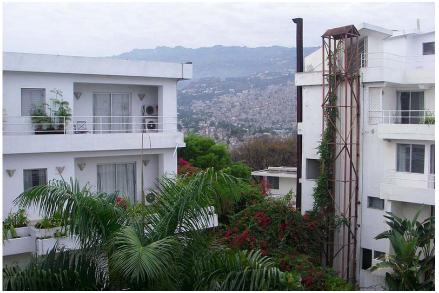
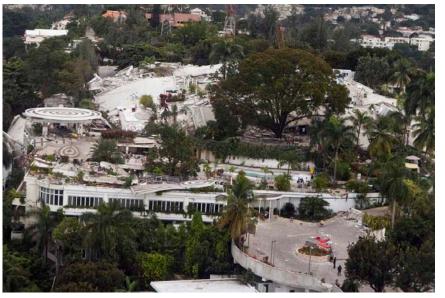
#### Hotel Montana, Haiti 4-star hotel

originally built in 1946

Expanded to include shops, a swimming pool and conference facility.

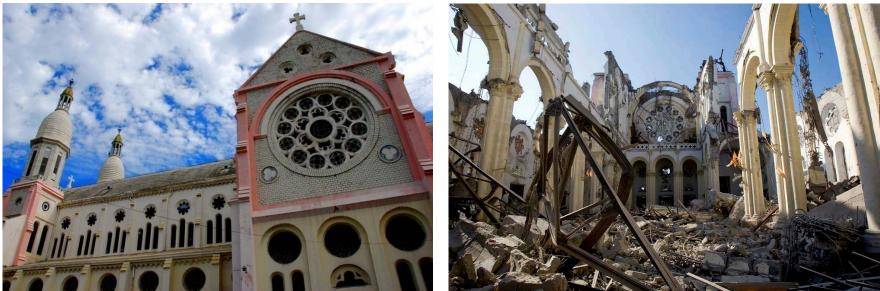
#### The Cathedral of Our Lady of the Assumption, Haiti

Built between 1884 and 1914, and was dedicated on December 13, 1928

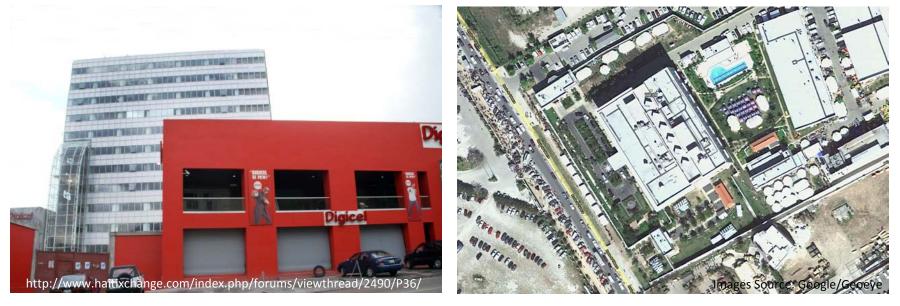
#### Reinforced Concrete Construction, Haiti Built to International Building Code Requirements

Digicel 12-story Tower (tallest bldg in Port Au Prince) Port-au-Prince, Haiti

US Embassy Port-au-Prince, Haiti

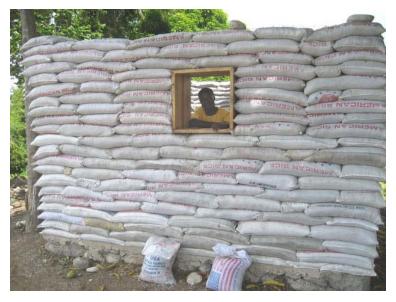
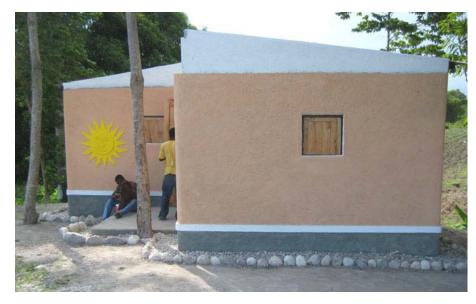
# Buildings that Survived, Residential Sandbag Construction, Haiti

#### Earthbag Sun House, Les Cayes, Haiti

Approximately 90 miles from Port-Au-Prince, the Sun House survived undamaged during Haiti's 7.0 earthquake. Neighboring buildings were destroyed.

Cal-Earth earthbag construction meets requirements for California Earthquake Building Codes

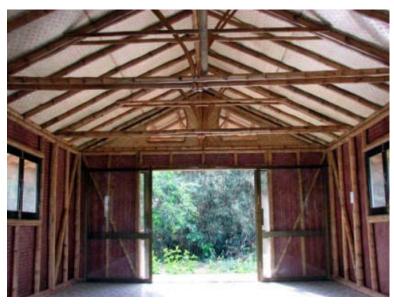
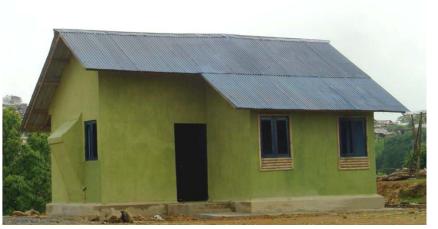
Bamboo system

#### Bamboo House, India

Can be engineered to meet earthquake and hurricane conditions.

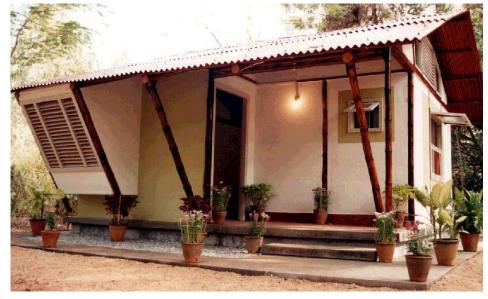
Bamboo House - India

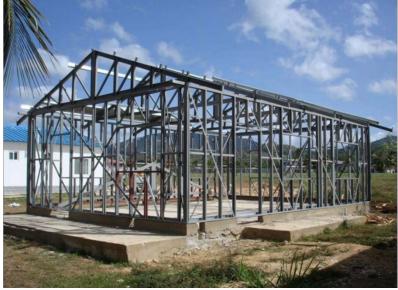
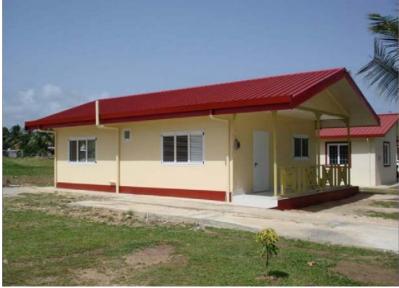
#### **Steel Frame on Concrete Slab**

System can be engineered to comply with CA Seismic Building Code and Miami Dade Hurricane Code

Completed Steel Frame House, 400 sf

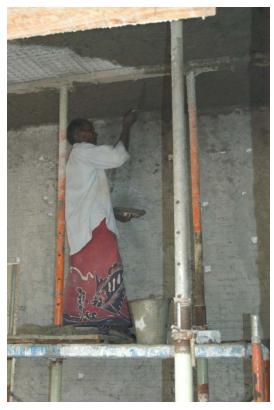
© 2005 Janice Olshesky Ministry of Housing, Colombo, Sri Lanka. Example Housing

Can be engineered to meet seismic and hurricane requirements.

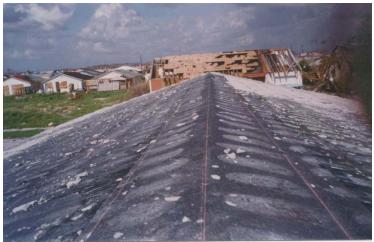
Photos taken after Hurricane Andrew in Homestead, FL. See roof picture below.

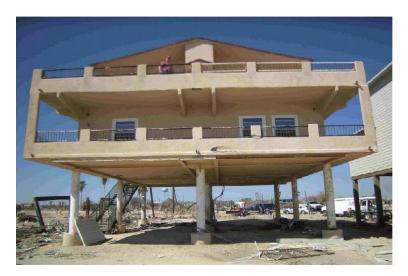
Crystal Beach House, Bolivar Island, Texas Post Hurricane Ike

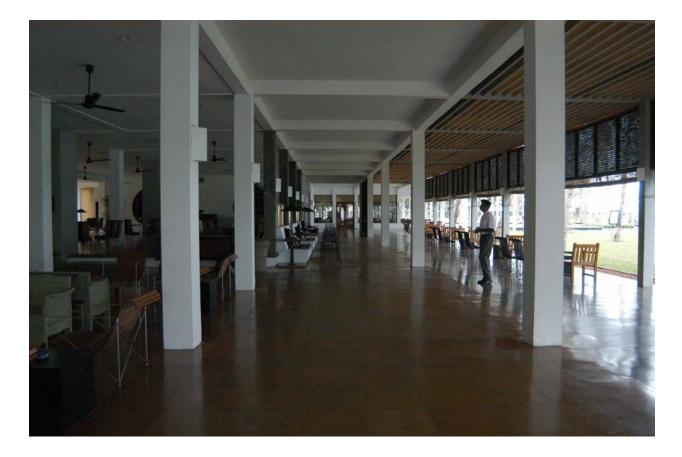
Blue Water Hotel: Open Piazza at Ground level allows the wave energy to pass through the structure and minimize damage

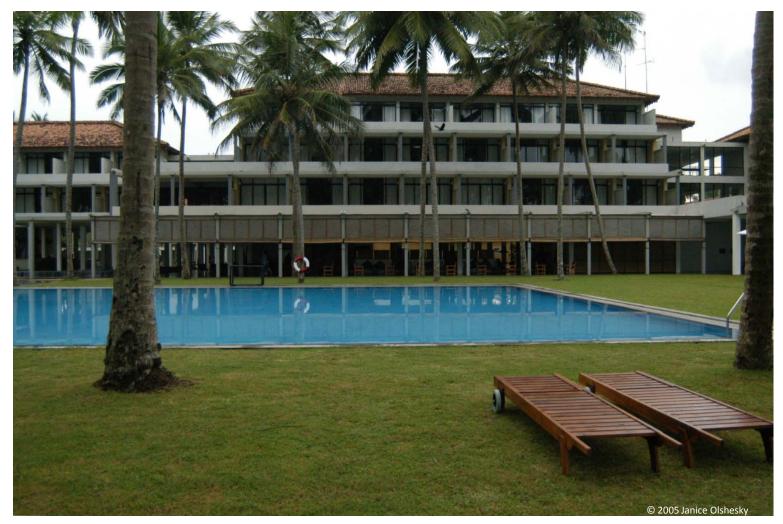
### Reinforced Concrete Blue Water Hotel, Wadduwa, Sri Lanka

View from the Sea, Indian Ocean

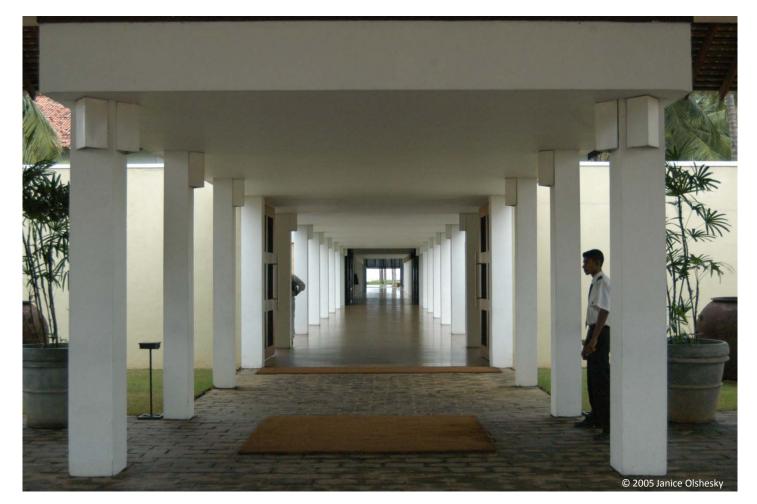
# Blue Water Hotel, Wadduwa, Sri Lanka elevated structure on columns

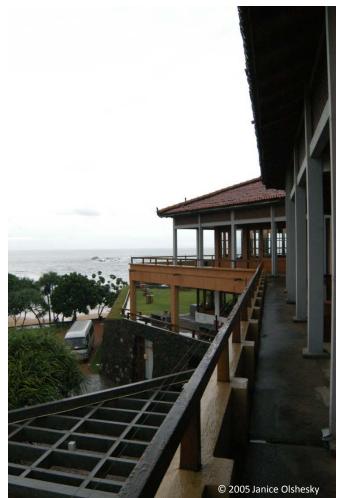
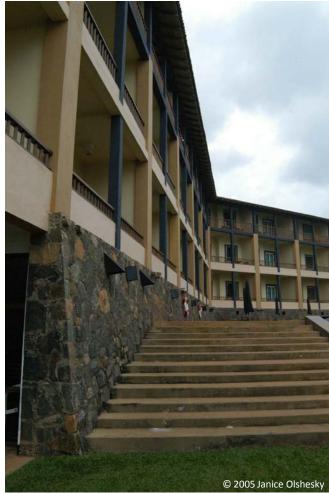
Built along oceanfront on rock outcropping, buttressed base Building Configuration- Flood Structure with many openings Lighthouse Hotel, Bath House

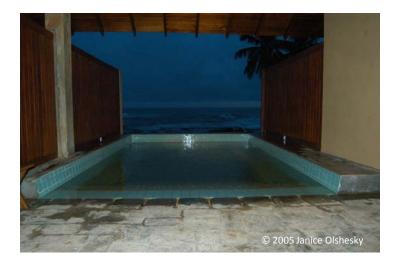
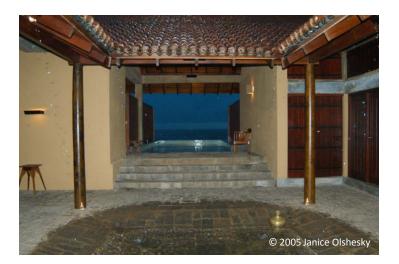
Damage was minor to this structure as water could move through it.

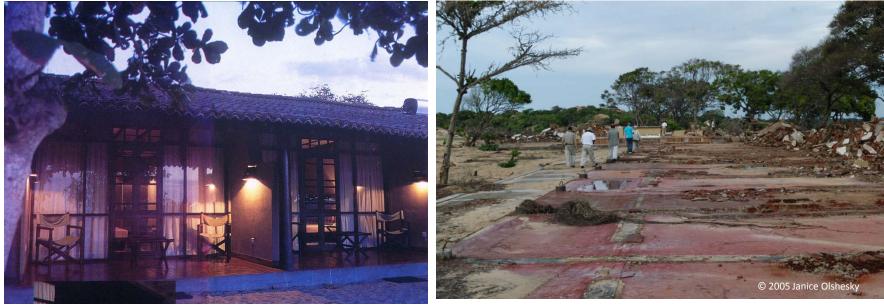
### Site and Ecosystem Yala Safari Hotel

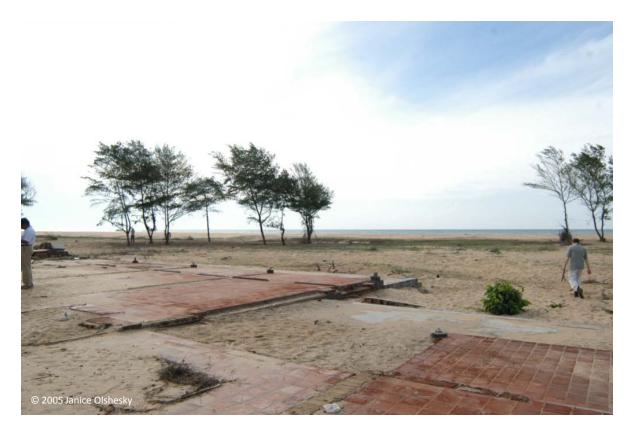
Before the Hotel was constructed, the natural sand dunes were removed for the guest's view of the Ocean

The Yala Safari Hotel was completely destroyed by the Tsunami.

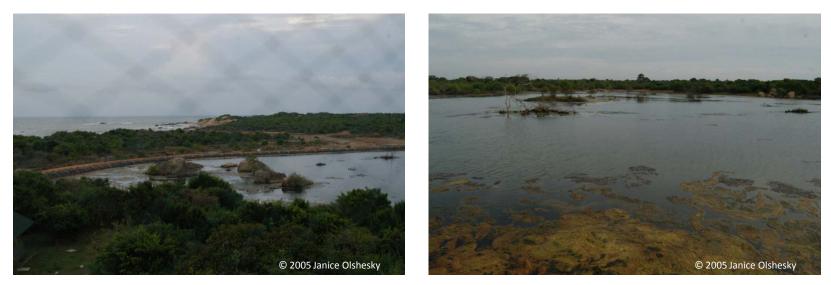
Ecosystem was undisturbed during construction

Cabin Roofs amongst trees

Ecosystem was undisturbed at Yala Safari Cabins. The sand dunes and mangrove trees were left intact. The Manager told us the water in the lagoon rose up but not too high. He explained the cabins sustained only minor damage, roof shingles had to be replaced.

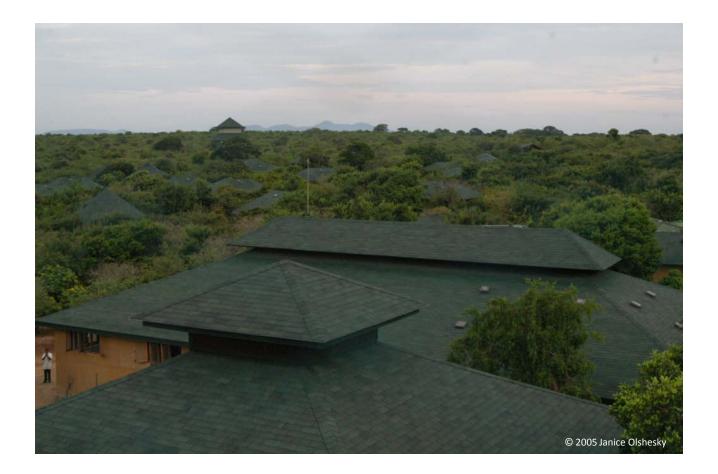
View from Dining Hall looking away from the Ocean from the same vantage point as the previous slide.
